# The AT&SF RAILROAD SHOPS AND OPERATIONS at San Marcial, New Mexico

*San Marcial, NM was once a bustling railroad town for the Santa Fe railroad, the second largest town in Socorro County, destroyed by floods in 1929. Little remains of the town today. This report contains some of the history of the railroad operations once at San Marcial, the 1929 flood, and photographs, maps and identification of the roundhouse ruins from an SCHS field trip to the area in January 2018.*

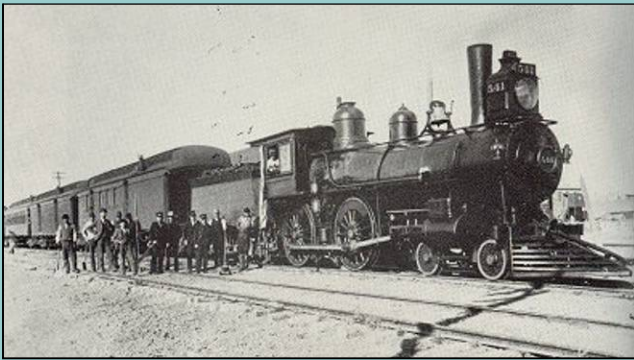
Photo: Kansas City Historical Society

**The standard engine in AT&SF freight service from 1880–1910 was the 4-4-0 type engine**

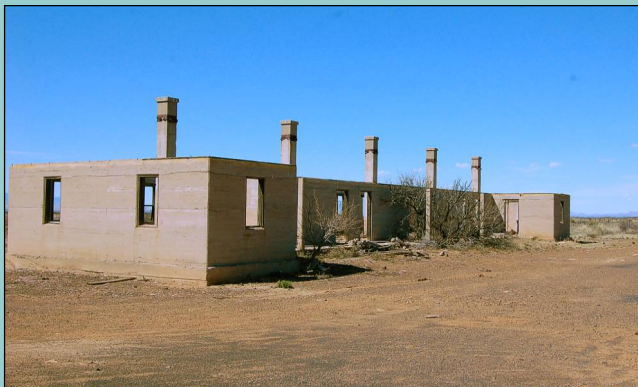
Photo: Paul Harden  
**Remnants of the San Marcial Division Section House at Lava Station (AT&SF milepost 1021.4) 16 mi. south of San Marcial.**

The AT&SF section houses were narrow and long single story buildings, much like a modern day motel. An end room served as a common kitchen. Two men lived in a room with a wood or coal stove for heating. Two rooms shared a chimney for their heating stoves.

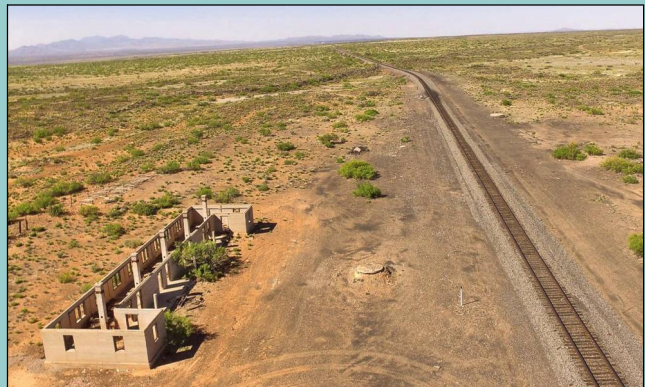
Photo: Paul Harden  
**Drone photo of the Lava Station Section House and water tank foundation, looking north towards San Marcial.**

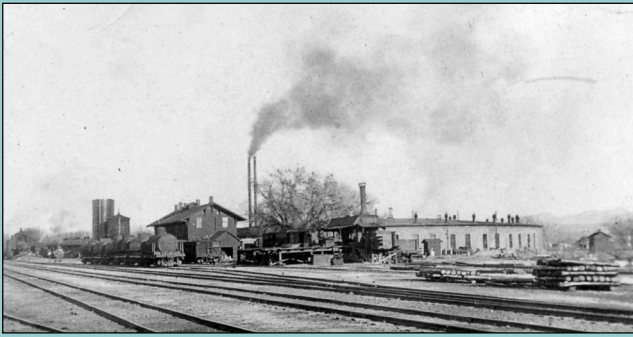
Photo: SCHS, Ralph Lane Collection  
**San Marcial maintenance shops and roundhouse, looking northeast, ca. 1919**

**Maintenance Shops** performed all general maintenance, major repairs, and the 1472 Rule overhauls of the locomotives. The San Marcial shops were extensive with the best lathes, milling machines, forges, and other machinery powered by their own steam power plant.

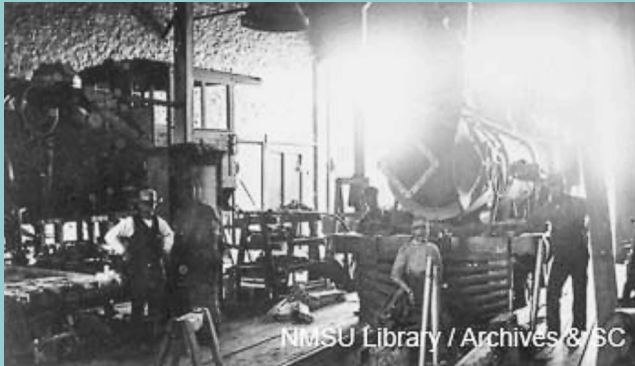
Photo: NMSU Photo Archives [Image #03620017 ]

**Inside the San Marcial roundhouse. Collection states photo taken in 1885, shortly after being built.**

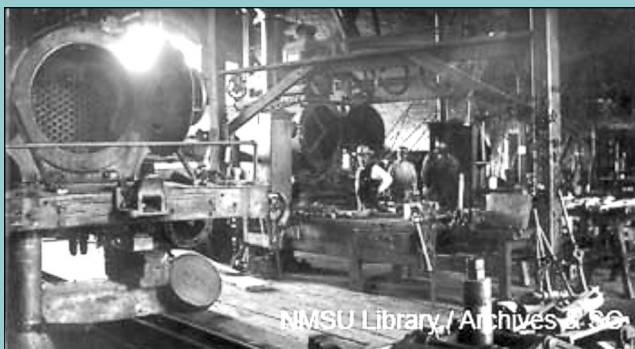
Photo: NMSU Photo Archives [Image # 03620018]

**Inside the San Marcial roundhouse performing an engine boiler rebuild, ca. 1918**

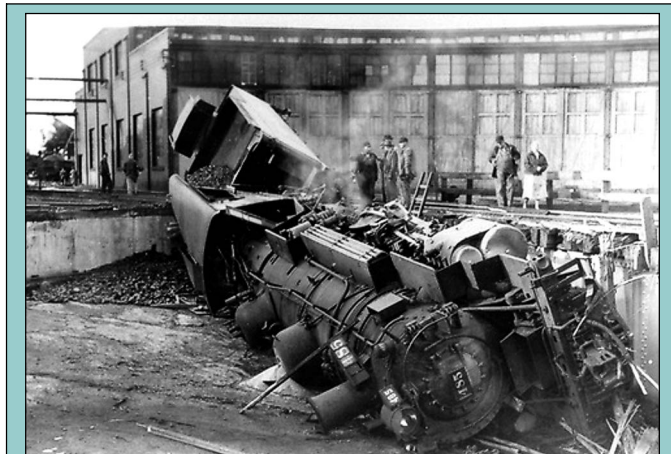
**D&RGW engine #485 was a total loss and scrapped after rolling into the turntable pit at Salida, CO.**

The photo on page 6 shows the result of a turntable mishap. In this case, the D&RGW engine had just received her 1742 Rule complete overhaul in the shops at Salida, CO in December 1953. It had just been fired up and moved out of the shop. The engine had not yet been properly chocked or chained to prevent accidental movement. A leaky throttle caused the engine to creep forward along the track leading to the turntable, which was not in proper

position. The engine struck the side of the misaligned turntable, causing it to derail, and engine 485 (a Baldwin K-36 4-8-4 narrow gauge engine) tumbled into the turntable pit. The frame was severely bent and the engineer's side drive cylinder cracked open, causing the D&RGW to declare it a complete loss. It was scrapped in 1955.

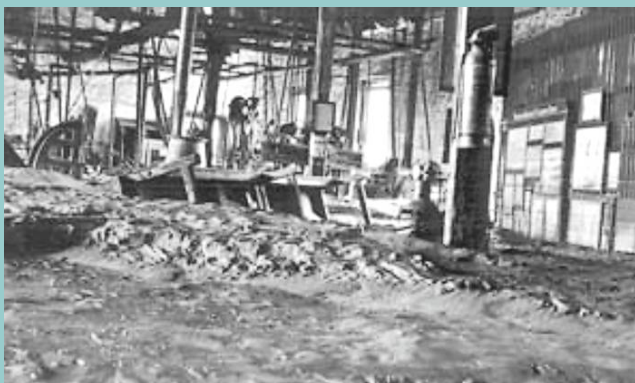
**Destroyed San Marcial machine shop after the first flood with 3–4 feet of silt in the shop buildings.**

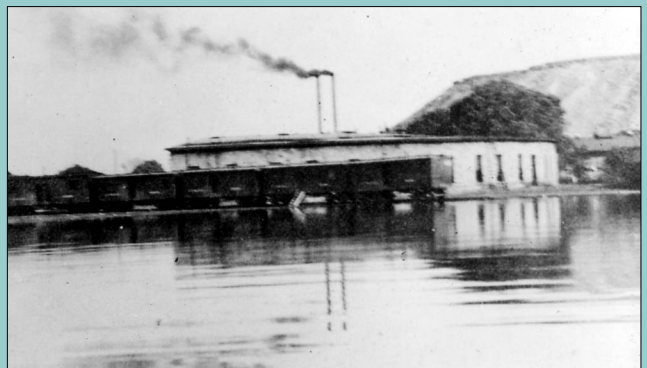
**AT&SF shops and roundhouse being swamped by the levy break during the second flood. Later in the flood, the shops and roundhouse collapsed.**

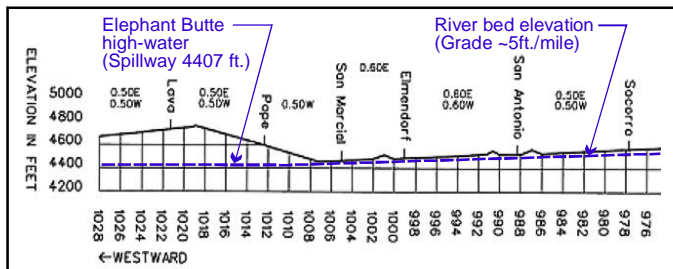
**Track elevation chart from about Engle to Socorro, clearly showing San Marcial at the low point of the line and follows the river elevation from Socorro.**

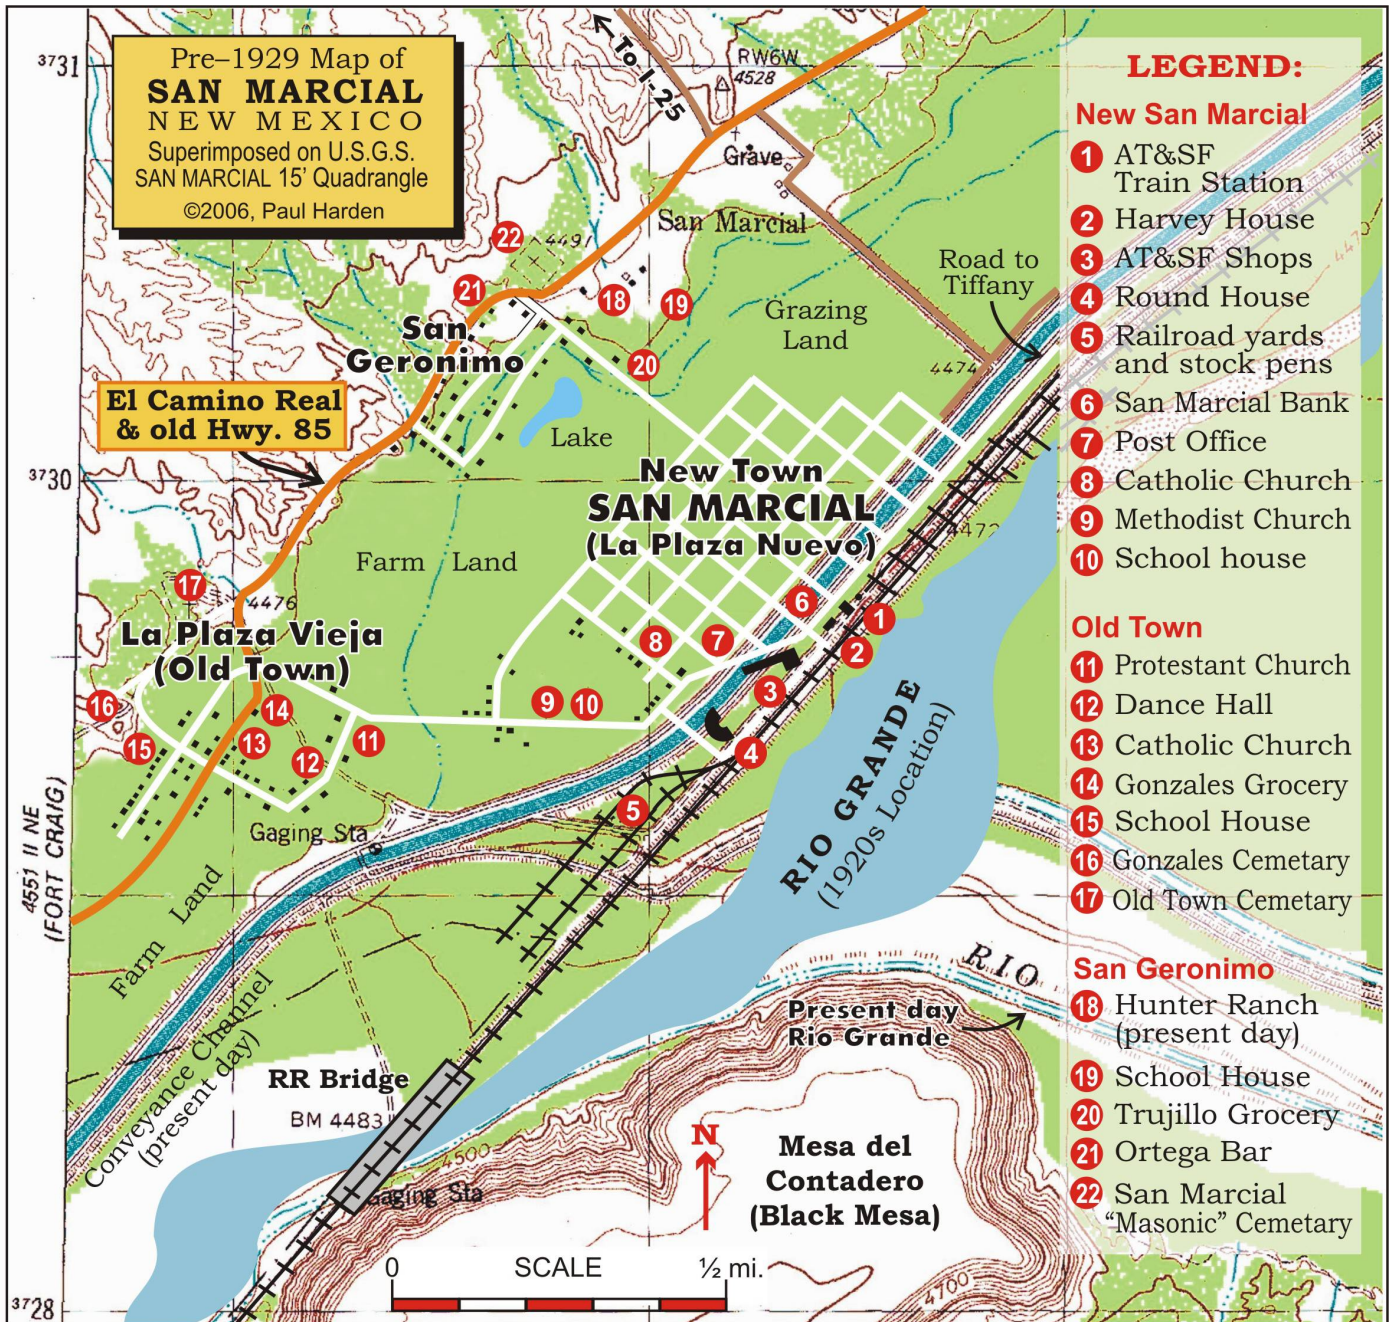
Assessor's Office and Middle Rio Grande Conservancy District) onto a present day USGS 7.5 min. San Marcial topo map. Little remains of San Marcial today. The map gives a fairly accurate portrayal of where San Marcial and pertinent features once stood.

**San Marcial Map** – The following map was constructed by superimposing a pre-1929 land owner map and survey map (Socorro County Court House,

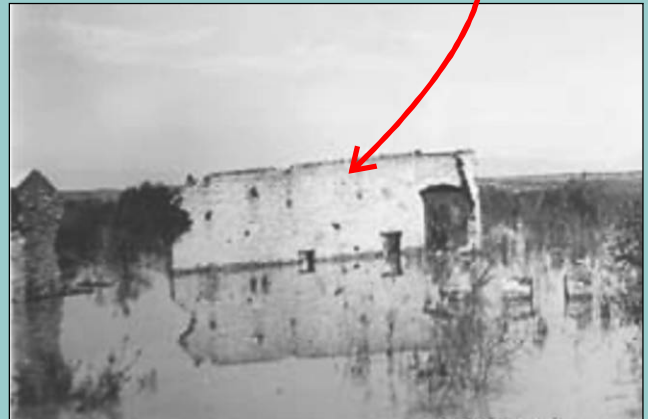
1937 flood photo which Herbert Yeo describes as "the roundhouse ruins from the 1929 flood." Ruins in 2018 appear little changed from the 1929 ruins.

Photo: NMSU/Herbert Yeo Collection [image #00940131]  
Roundhouse was destroyed in the 2nd 1929 flood. Appearance of ruins during 1937 flood, looking south.

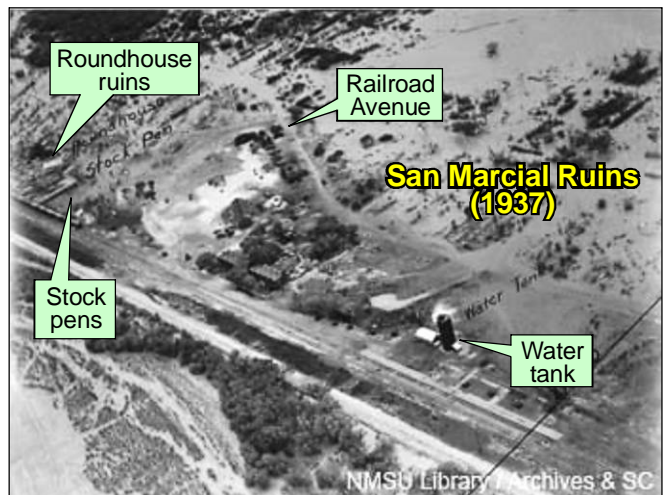
Photo: NMSU/Herbert Yeo Collection [Image #00940107]

1937 aerial photo, looking southwest, showing remnants of the San Marcial roundhouse, shops and water tank.

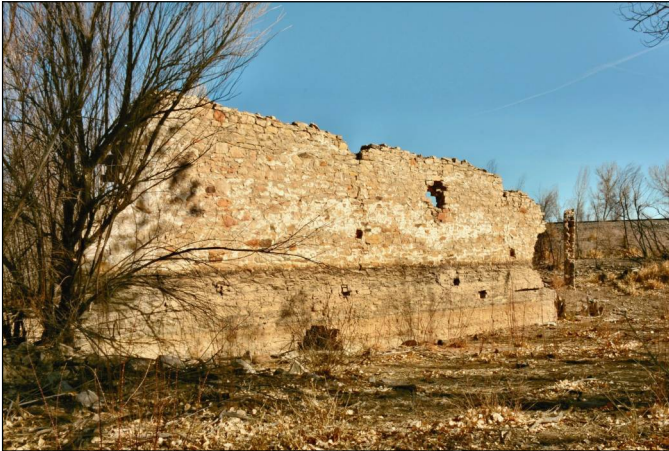
Existing remnant of the roundhouse northeast wall segment, looking east; turntable was to the left (no remnants remain).

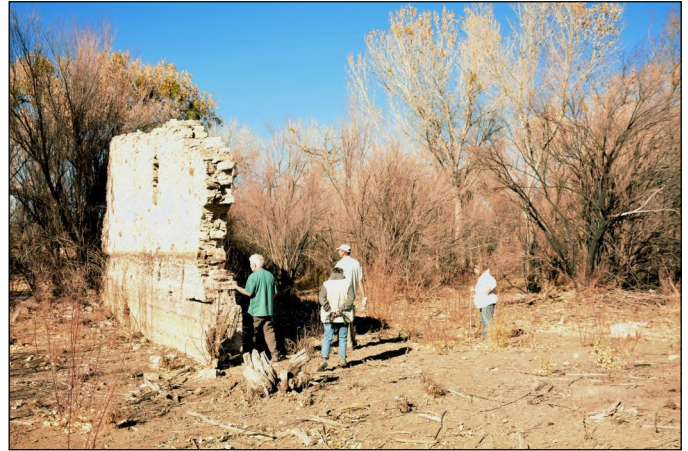
Inspecting the roundhouse wall, looking west. Note water stain on wall, depth of 1929 flood waters.

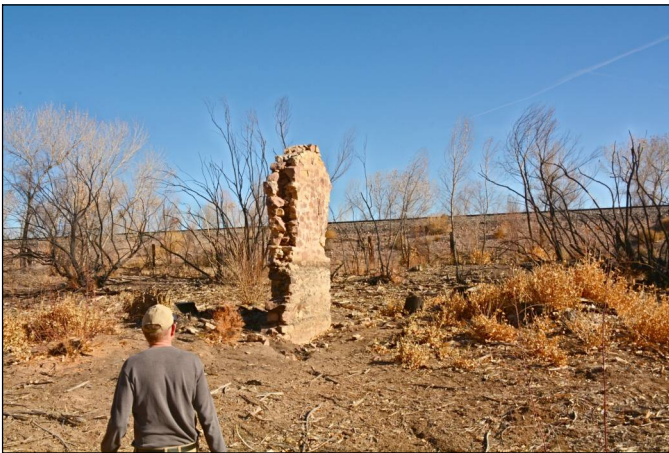
Existing remnant of the back wall of the Foreman's shack, once supporting a pitch roof.

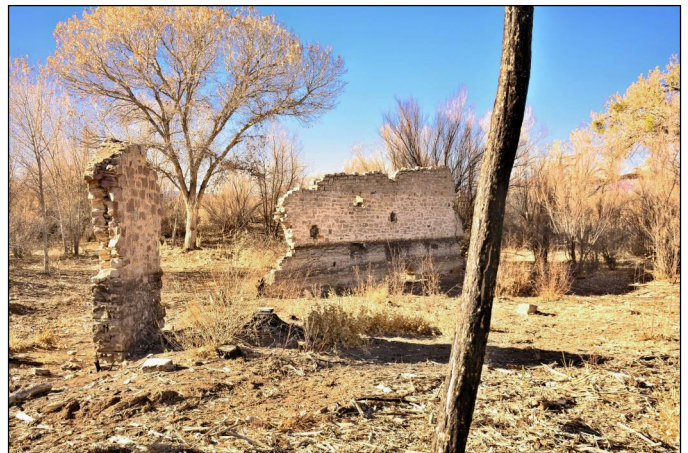
View looking west at Foreman's shack wall (left) and roundhouse wall (center).

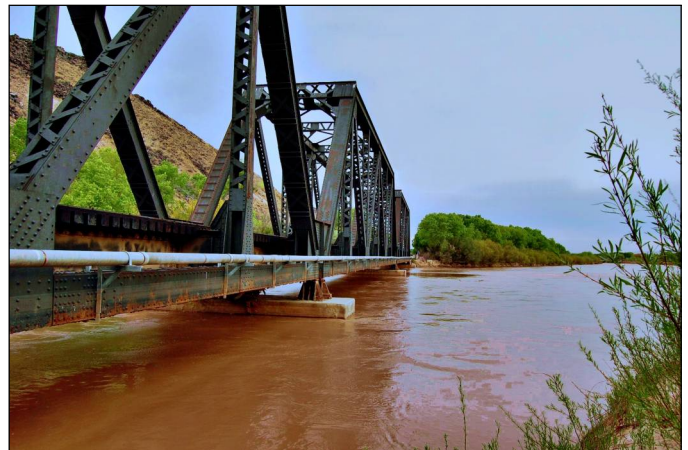
Mainline trestle across the Rio Grande, looking south, the entrance to the Jornada del Muerto and higher ground. Bridge was raised 8 feet after 1929 flood. AT&SF milepost 1005.8
